**LANDSLIDE SUSCEPTIBILITY MAPPING AND GEOLOGICAL STUDY IN
KALIGANDAKI RURAL MUNICIPALITY, GULMI,
CENTRAL NEPAL**

Field Report

Nabin Geo Solution and Consultancy Pvt. Ltd

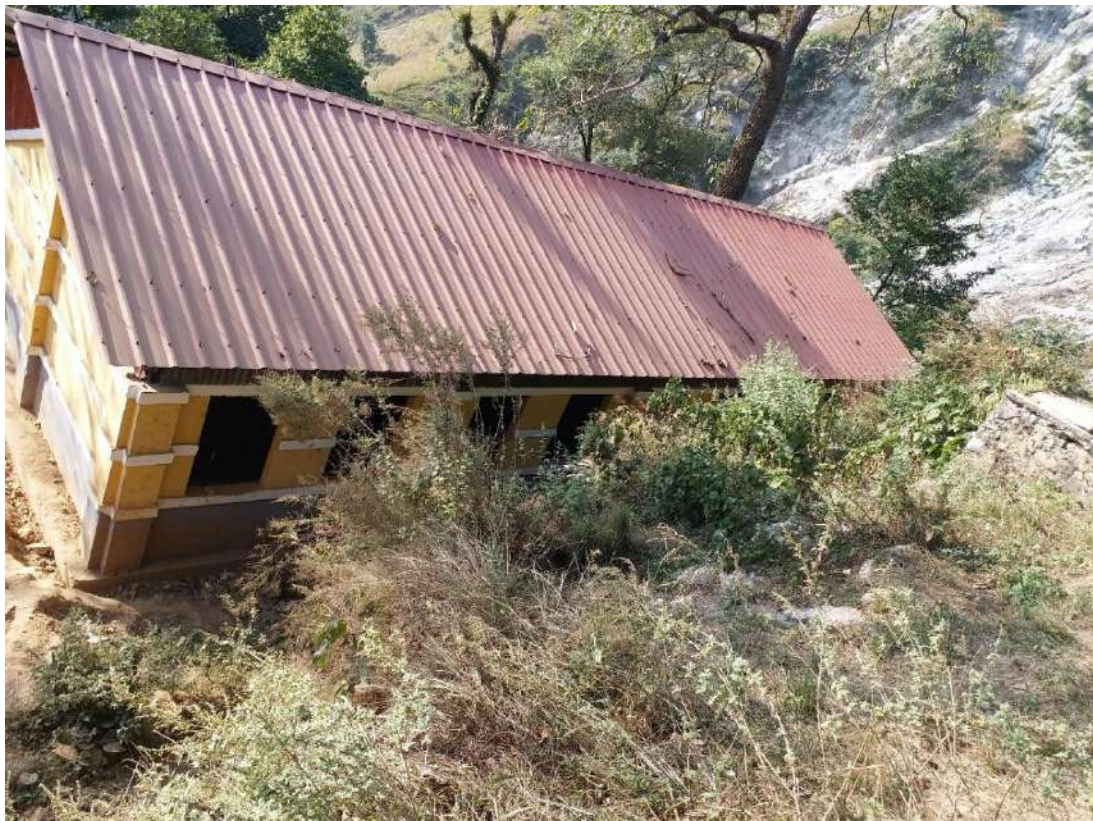
Photo:1 School Building

Geologically this area is located at Dhading dolomite formation and there is rough and steep terrain. Giduwa was the first study area and guided by Mr. Preetam Singh Rana, there is found lots of shallow landslide, had happened during this monsoon. NERA school building is high risk of landslide both upper and lower building because there has already landslide gone and lower building will affect if extension of road. Similarly, backward of upper building had been built some retaining wall but it couldn't stabilized the slope failure. For the protection of this building, we should do proper retaining wall with bioengineering on this area.

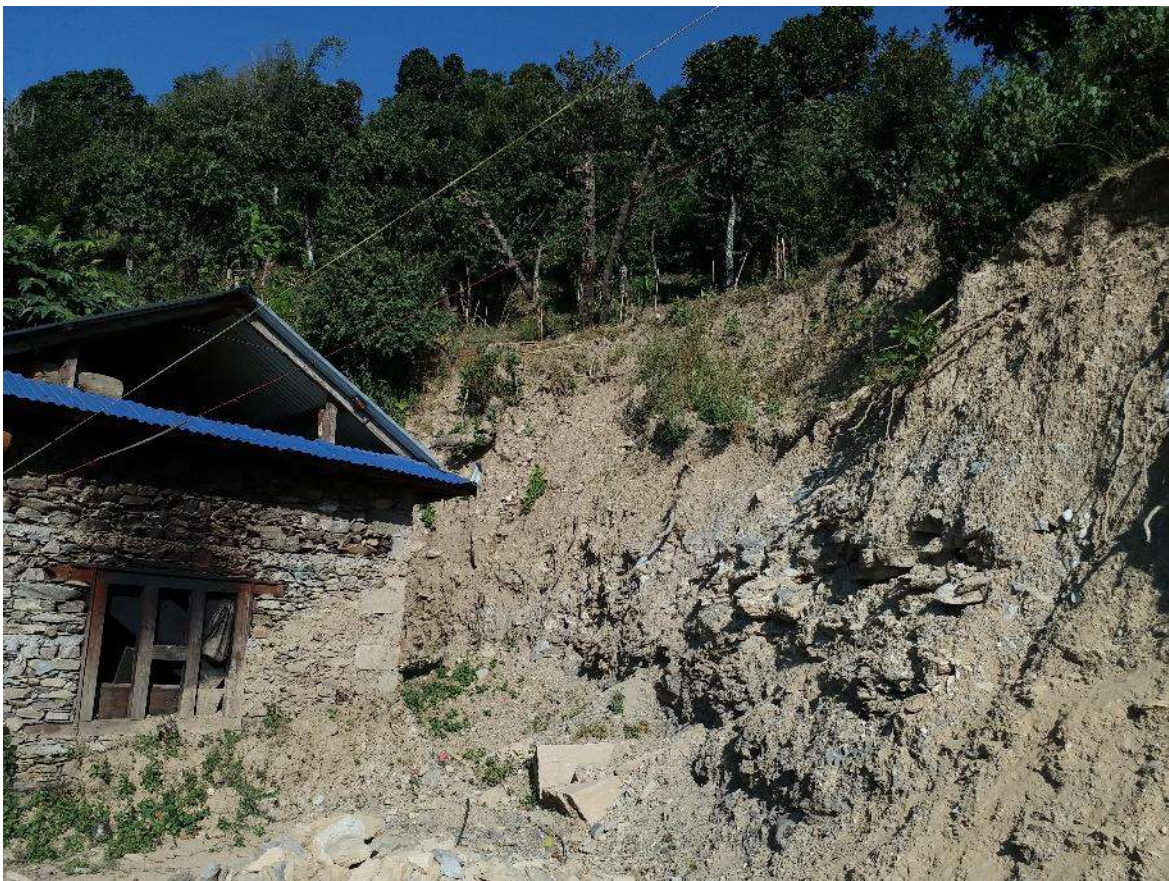
Photo:2 Newly Formed House

Janajyoti Primary School, Vayakot is high risk of landslide because forward and backward side of school building was observed landslide. The soil type of this area is silty gravel and colluvial soil. The main causes of landslide is not proper channeling of rain water during monsoon. Similarly, Hira Bahadur Thapa house is high risk of landslide in Vayakot because both backward and forward of this house has gone landslide. The main causes of this landslide are high step of slope and weak soil and geology.

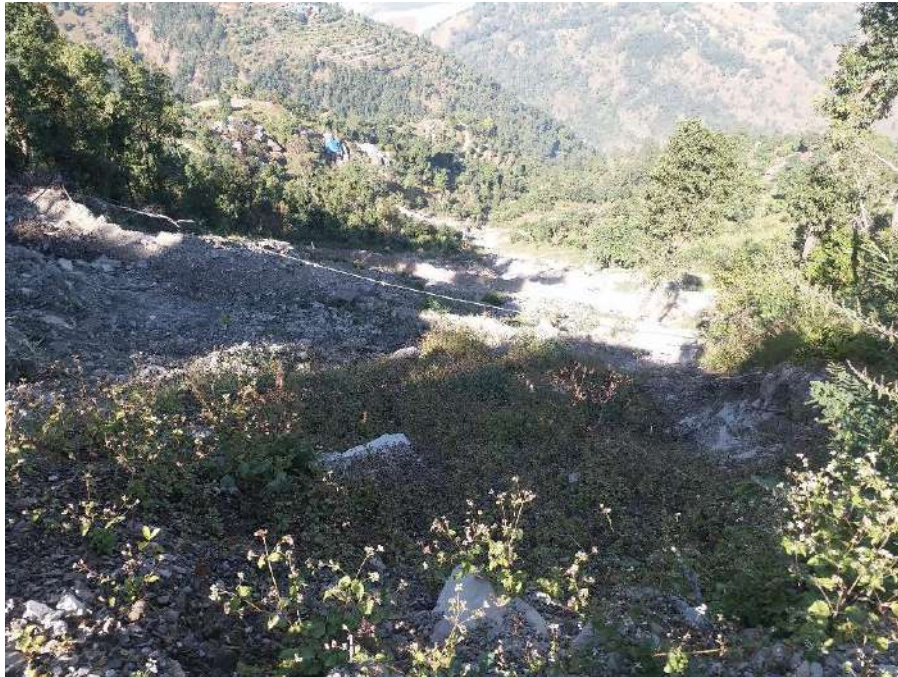
Photo:3 Landslide at Nigare village

Nigare village landslide is man made landslide, causes of landslide is low budget road construction, weak and fragile geology. This track was open without proper knowledge of geology and geomorphology. And another big mistake was track open beyond the DPR. There is high risk of landslide and it directly affects five houses. Geology of this area is highly weathered phyllite and colluvial soil with steep (45 degree) slope. Road constructed as like butchering of the hill and its consequences, there is lots of cut slope failure and crack

developed on depositional, cut slope masses. Another risk factor is large boulder (29 m×28 m×10 m) was observed, has appeared during road construction 200 m above the village and which is high probability of slide during monsoon or earthquake therefore this village is high risk of disaster.

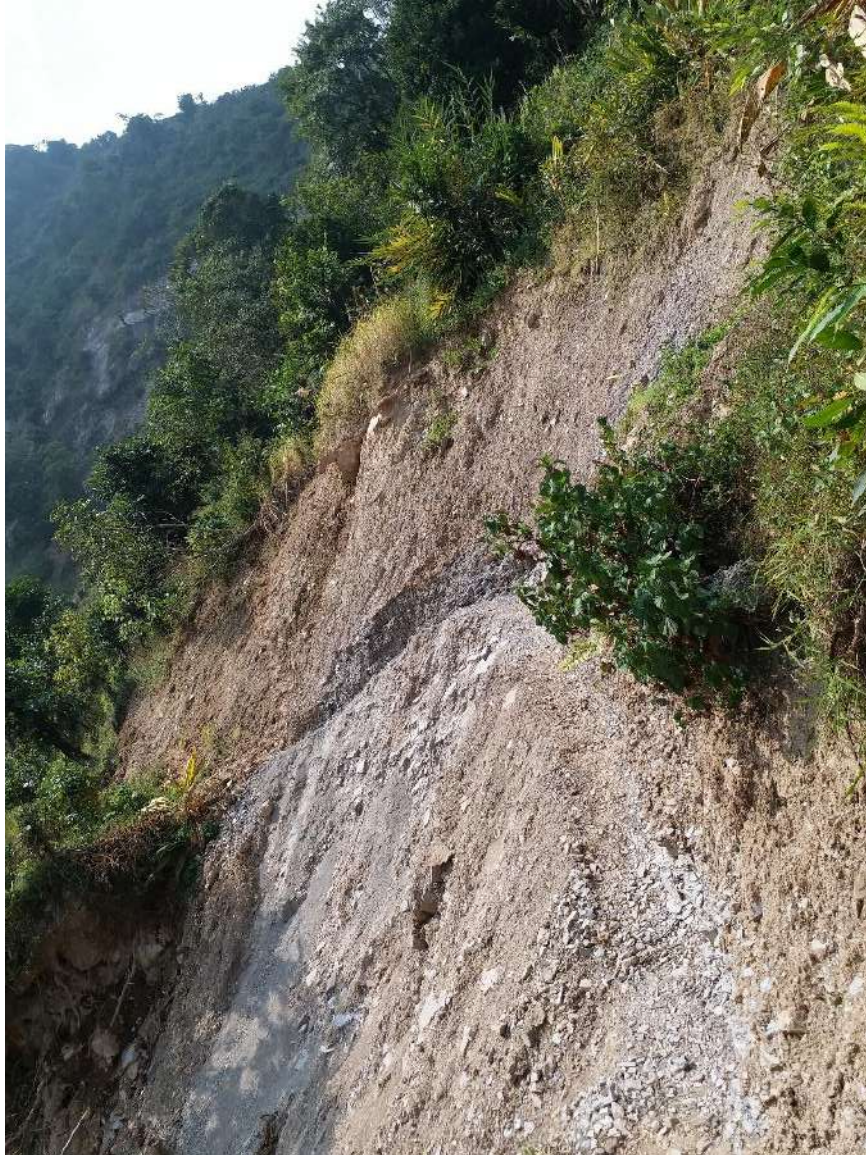
Photo:5 Landslide at Lamsarang

At Lamsarang Mr. Yam Bdr Thapa house is high risk of landslide because there is high angle slope (40 degree) terrain and landslide has occurred on this monsoon and there is lots of crack develop in the top of landslide. The lithology is silty gravel with highly crushed phyllite.

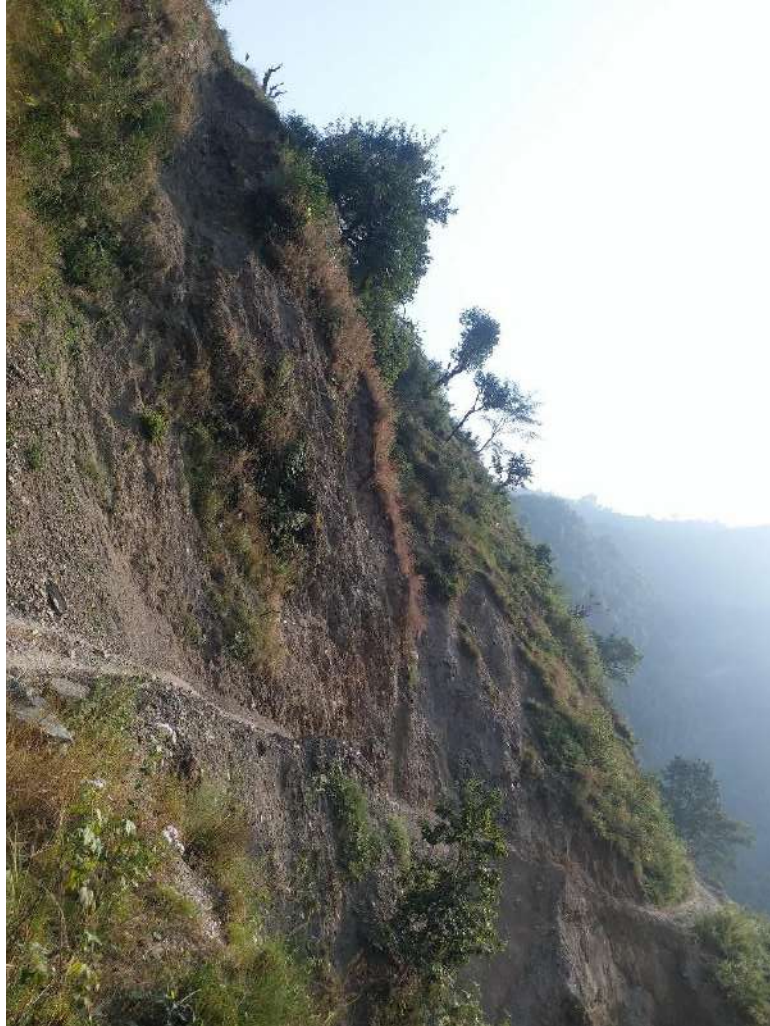
Photo:6 Landslide at Nayakhani

Nayakhani is another vulnerable area where three houses are directly affected by landslide, there is landslide on both sides of the village. Geologically this area is weak and highly weathered phyllite and colluvial soil. At the left side of the village there is a series of landslides. Similarly, just 200 m above the previous slide there is a man-made slide observed, i.e. caused by road construction. Three houses are directly affected by this slide.

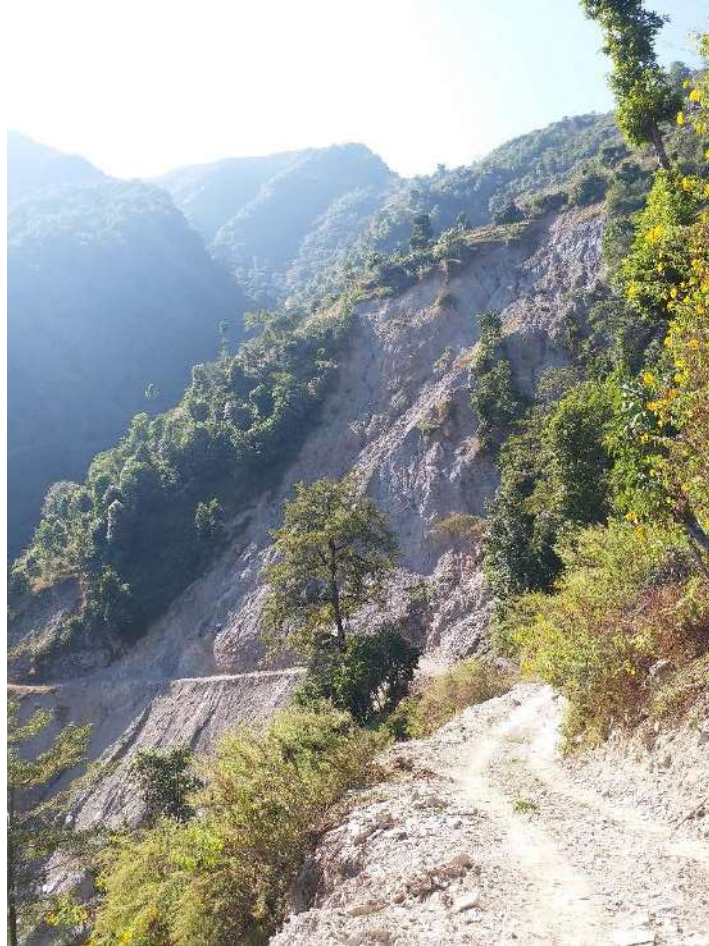
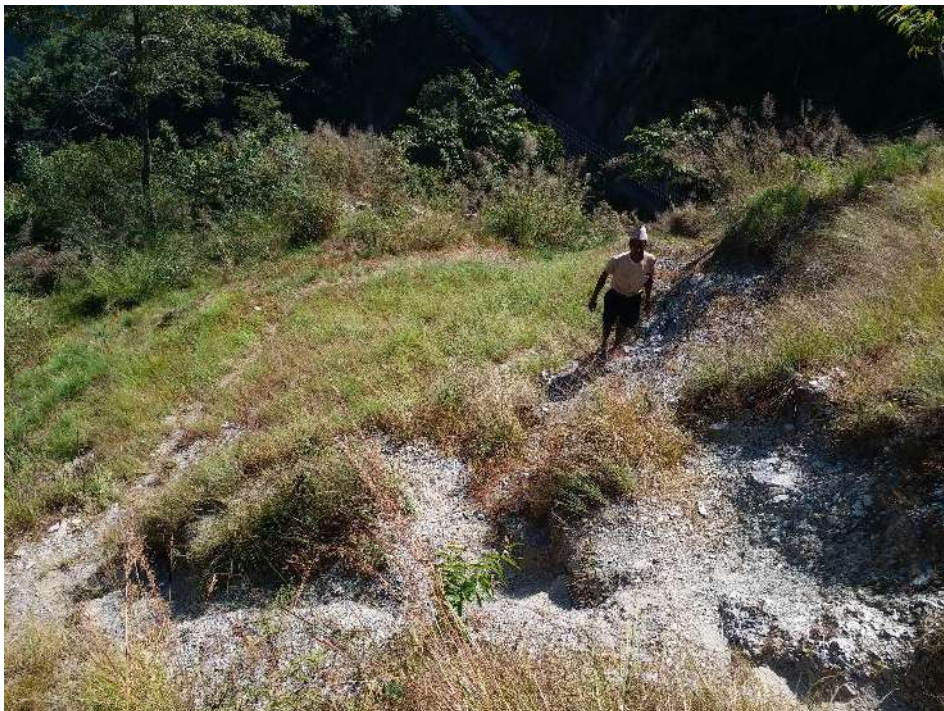
Photo:7 Landslide at Saureni village

Saurani village is high risk of landslide because there is three houses are affected and one house had already destroyed. The geology of this area is weathered dolomite and this is the main caused of landslide. Another risk area is Bhangkharka, Mr. Min Bdr Bhandari house is very risk of landslide. In this monsoon there had gone landslide which directly affected newly constructed road and his house. The lithology of this area is weathered phyllite, slate and colluvial soil. The main causes of landslide are construction of road below the landslide and weak geology. There is lots of crack developed in top and right side of the landslide therefore this area is high risk of landslide.

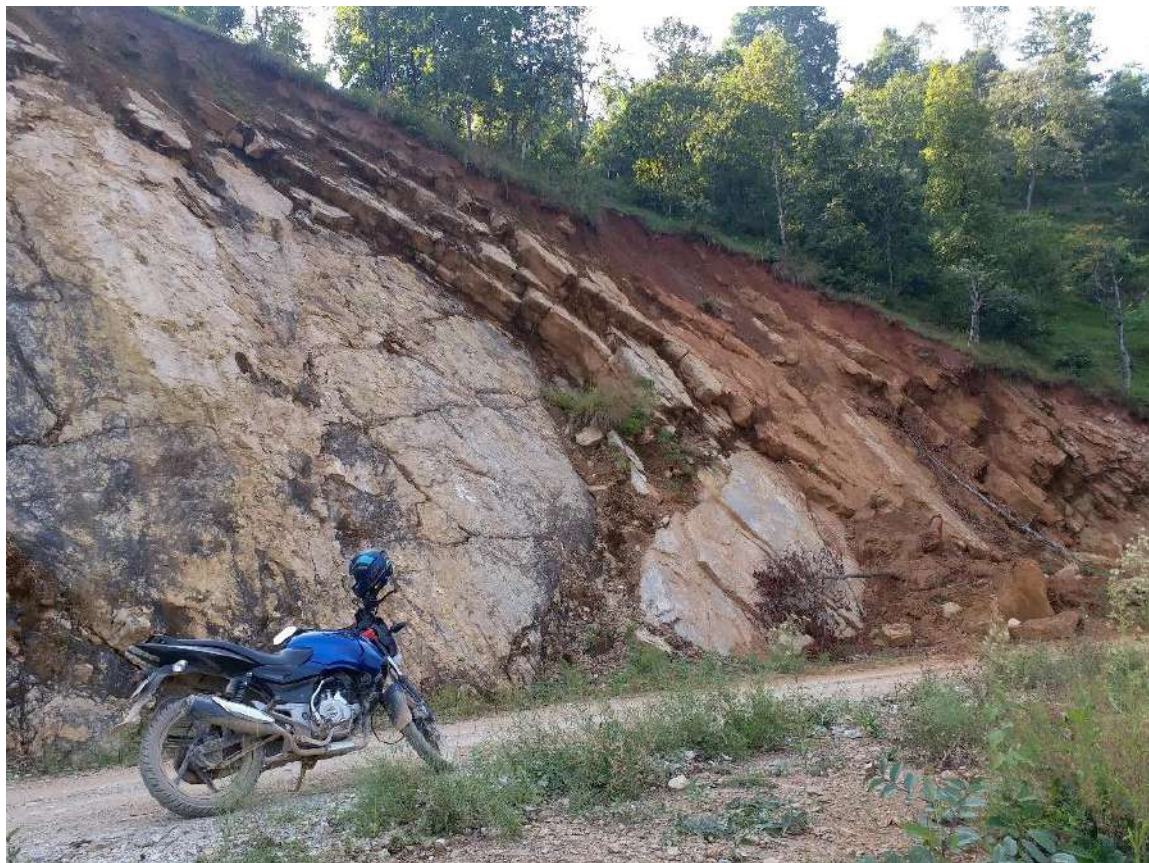
Photo:8 Dolomite Rock Slide

At 500 m ahead Danda village, a landslide was observed which affected road and cultivation land below the road i.e. Latitude 28.06757, longitude 83.53634. The main causes of landslide are road construction and failure of depositional material. The lithology of this area is dolomite rock.

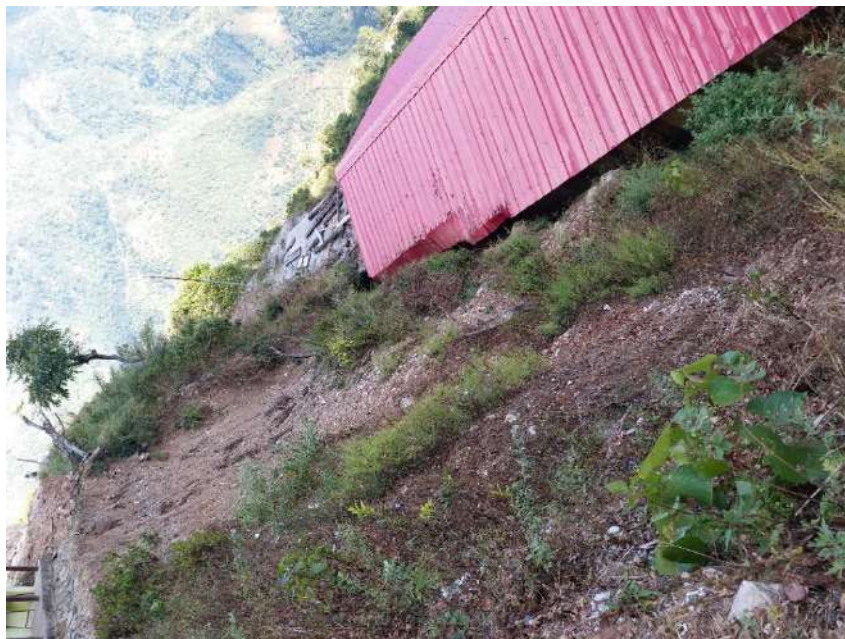
Photo:9 Landslide at Lung School

Backward from the Lung village at Shree Sukra Secondary School a cut slope failure was observed and it directly affected school building. The main cause of landslide is depositional material has filed due to high steep of slope and loose compactness of soil. The main lithology of this area is dolomite and silty gravel. The location of this area is Latitude 28.11617, Longitude 83.54178. For the protection of this building requires gabion/concrete wall.

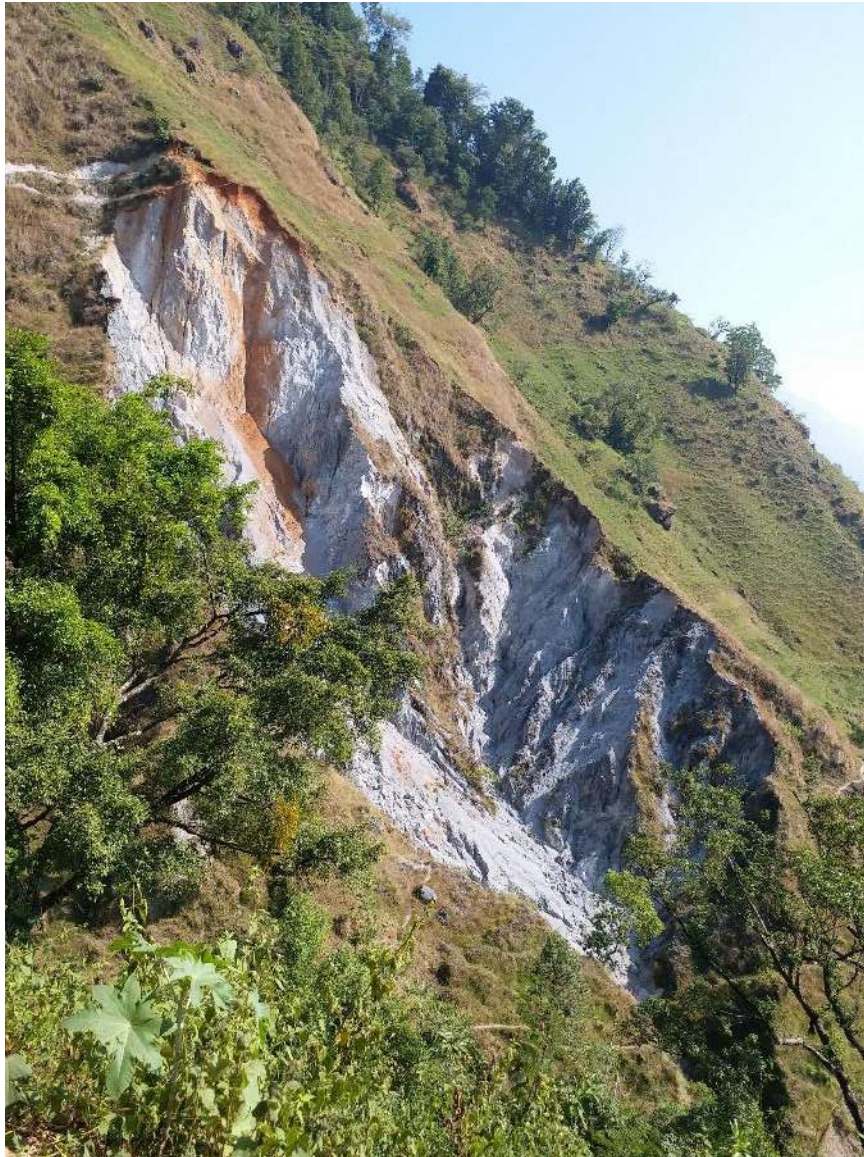
Photo:10 Landslide at Lower Korang

Similarly at lower Korang, series of landslide was observed and it directly affects road obstruction. If this landslide occurs as similar way then it will affects cultivation land and some houses above this landslide. The main cause of landslide is weathered and crushed dolomite.

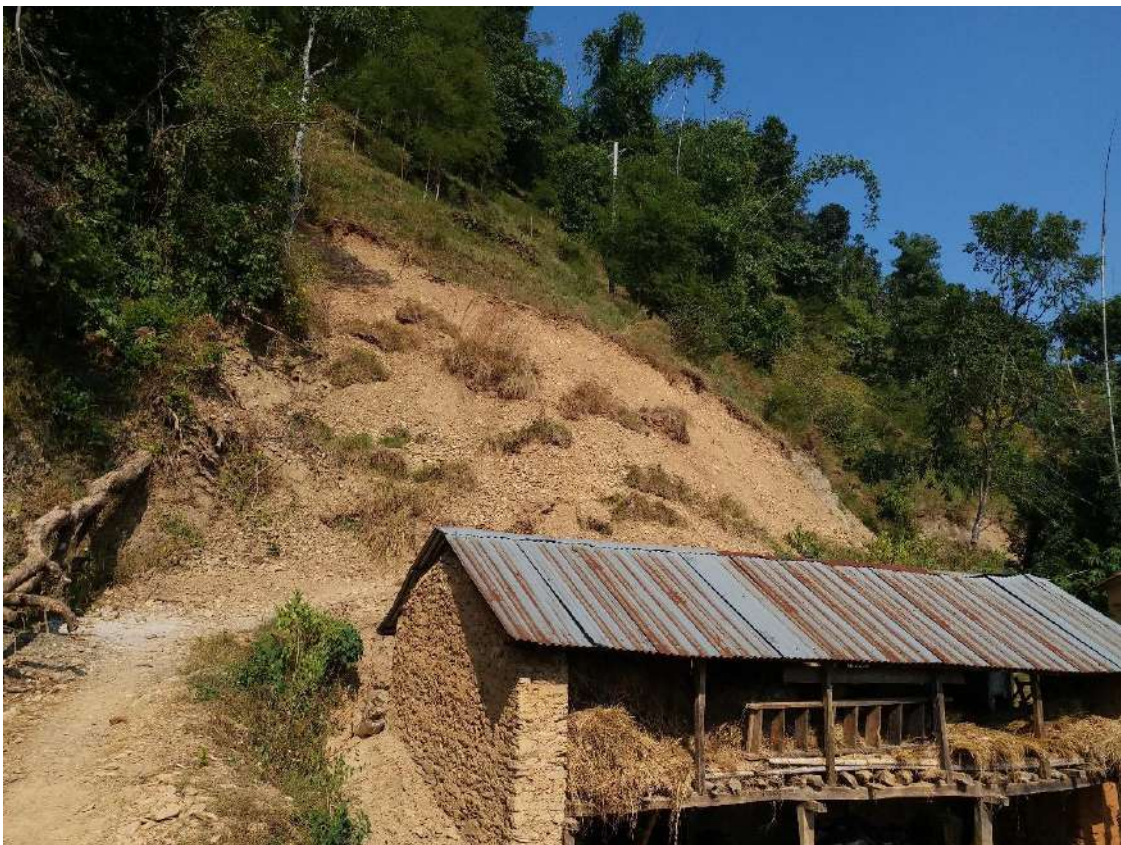
Photo:11 Landslide at Urleni Gaun

At Urleni, this area is geologically sensitive area and road are constructed without proper channeling system in the road thus it affect directly and indirectly in our social activities. Without proper planning, low budget road has been constructed and its consequences seven houses are affected by this slope failures. The soil type of this area is colluvial soil and there is high possibility of landslide. This area is highly fragile geology i.e. weak geology and was observed ancient landslide also. The road has been constructed in between the village which is the major problem and its consequences slope failures has occurred. To continue of this road is major challenging for construction by low budget i.e. requires high budget (can do channel, protection wall, gabion, concrete wall etc., as consequently).

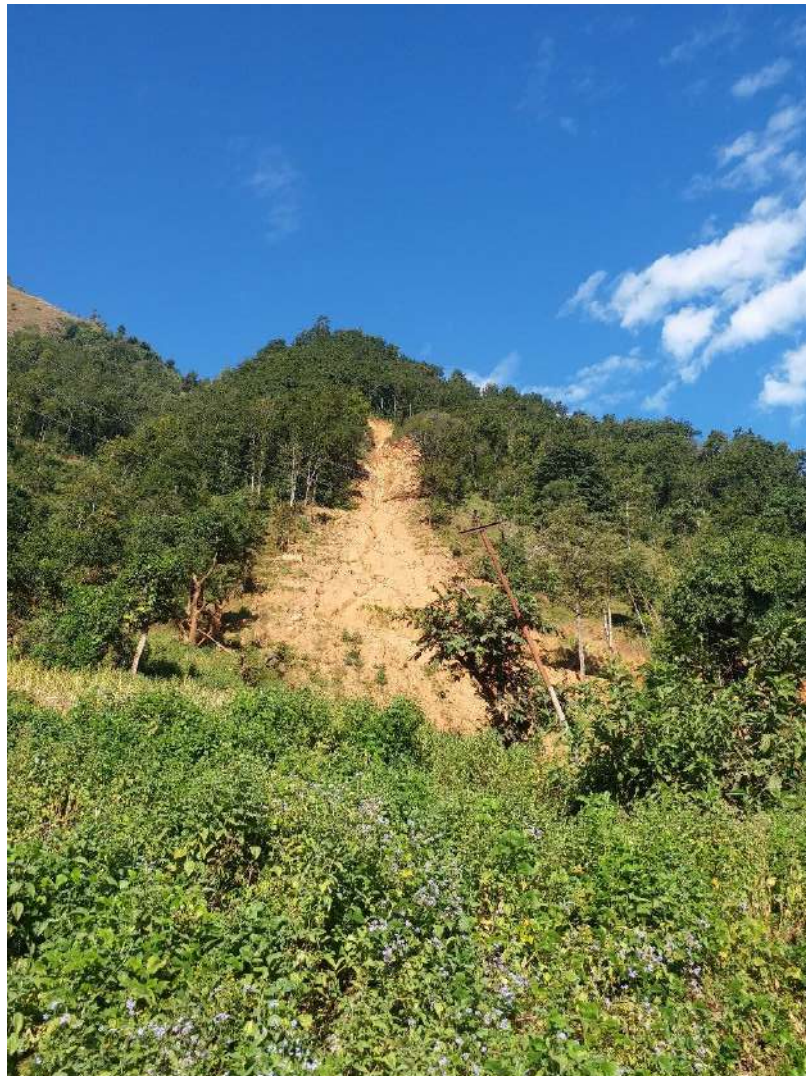
Photo:12 Landslide at Barlwa

At Baralwa, translational slide was observed which directly affected five houses. The main cause of this landslides is newly constructed low budget road. Small slide creates debris flow above the village. Residual soil (red clay) expanded due to absorption of water during this monsoon and failed.

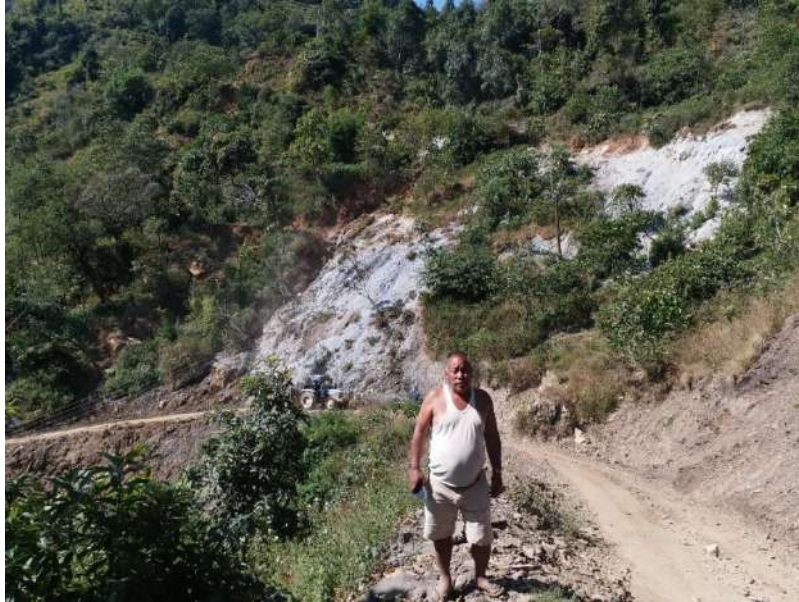
Photo:13 Landslide at Dhuwa Khola

At Dhuwa Khola Kanchane Gaunda, landslide was observed. The main causes of landslide are construction of road and seepage of water during monsoon in between clay layer of this slide. Geologically this area is very weak because there is a fault which affects this area more vulnerable and risk for landslide. The main lithology of this area is crushed dolomite and slate, due to the fault pressure, temperature dolomite and slate became white and black clay.

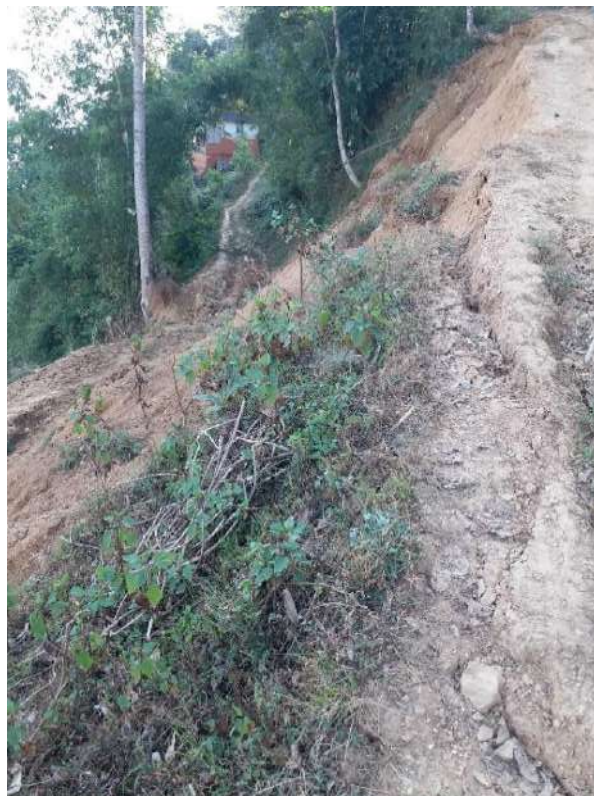
Photo:14 Landslide at Nayagaun

At Nayagaun village, two landslides were observed: one is a depositional mass that failed during this monsoon, and another is a cracked depositional mass. If this landmass failed, it would affect many houses. The main cause of the landslide is road construction without a proper water channeling system. The soil type in this area is residual silty clay.

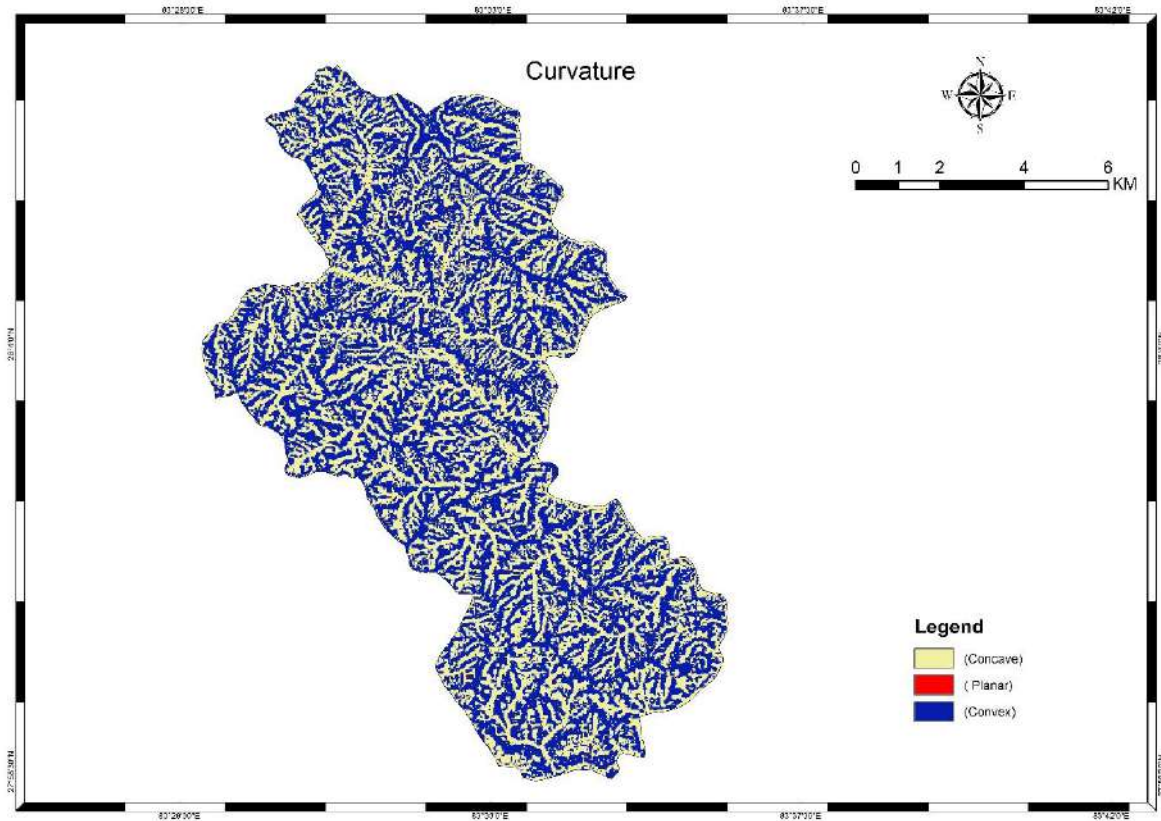
Fig:12 Curvature Map

The curvature (Figure 12) is the amount by which a curve deviates from being a straight line, or a surface deviates from being a plane. Curvature map was prepared using 25×25 m DEM using the algorithm aspect of Surface-Spatial Analyst Tool in ArcMap. Curvature is categorized into concave, linear and convex surface as shown in figure 12. Table 1 shows that the planar topography cover 47%, whereas concave topography covers 26.35% and 26.83 % area cover by convex topography of the study area. Most of the landslide have occurred in concave surface as 52.77% of total landslide lies in this zone. Hence Concave is more prone to landslide which is also supported by the frequency ratio that value 2.

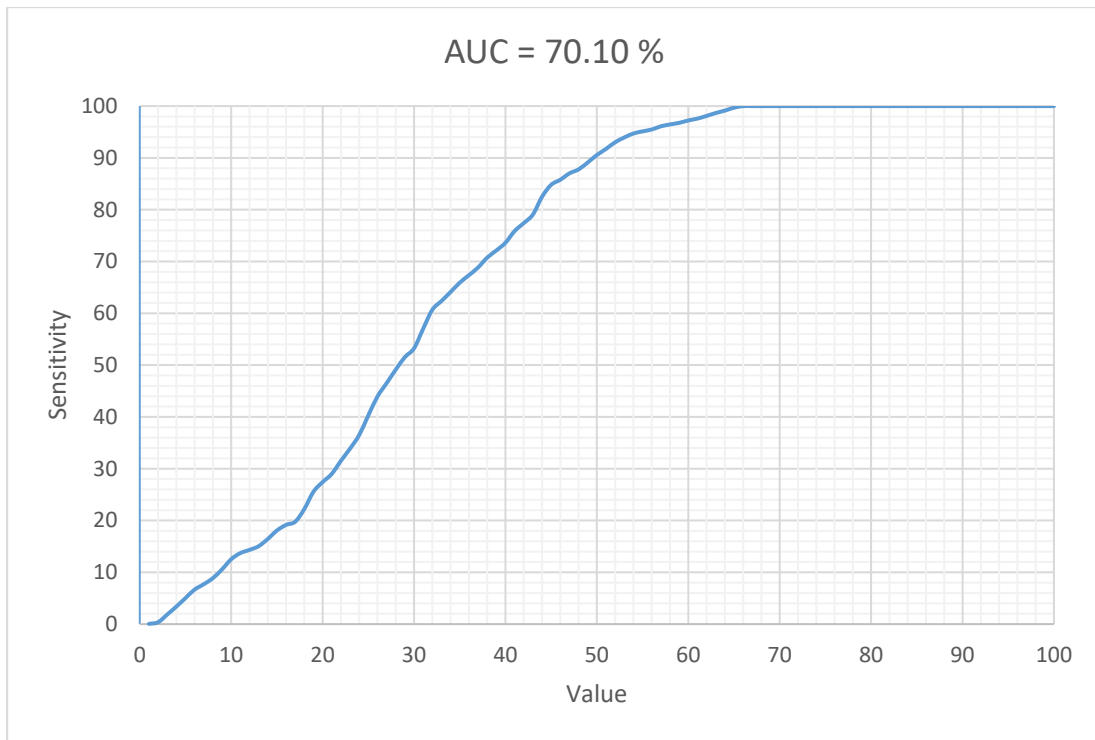
Fig:15 Area Under The Curve

For validation, landslide area which has not been used for the construction of model is generally considered as the future landslide area. In this study, all landslides (polygons) were divided into two parts (70% i.e. 35 landslides for modeling and 30% i.e. 15 for validation). Hence to check the predictive power of proposed method for Landslide Susceptibility Map, LSI was qualitatively examined using success rate curves Figure 15.

In above diagram (Figure 15), the area under the success rate curve (ROC/AUC) is 0.7010, indicating that the prediction rate was 70.10 %, the analysis is valid. Finally, three Landslide susceptibility classes (Table 4) are established as stable (greater than 52%), quasi-stable (24-52%), and unstable (0-24%) using which final landslide susceptibility maps was prepared (Figure 16).
